**Program Summary:**

The classical portico/primary façade of the historic 1850 Gallier Hall building was stabilized and restored. The restoration included both structural repairs and masonry cleaning.

## Gallier Hall

Project Name:  
**Gallier Hall: St. Charles Façade Restoration**

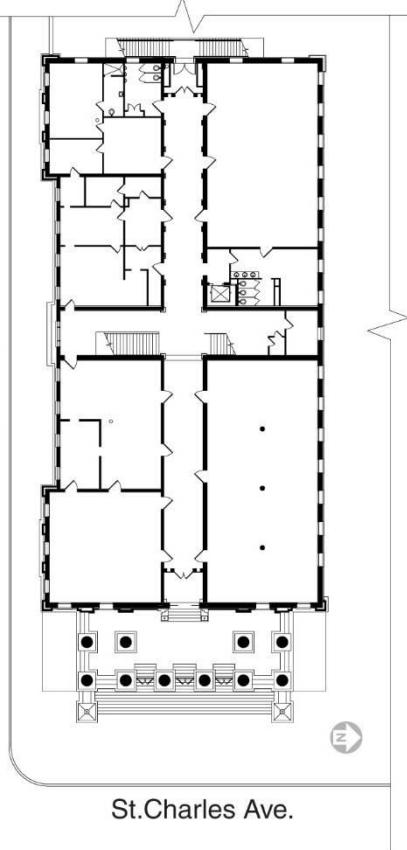
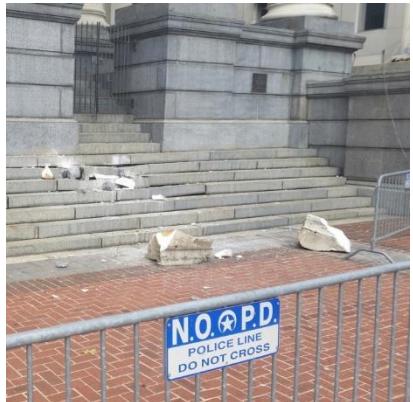
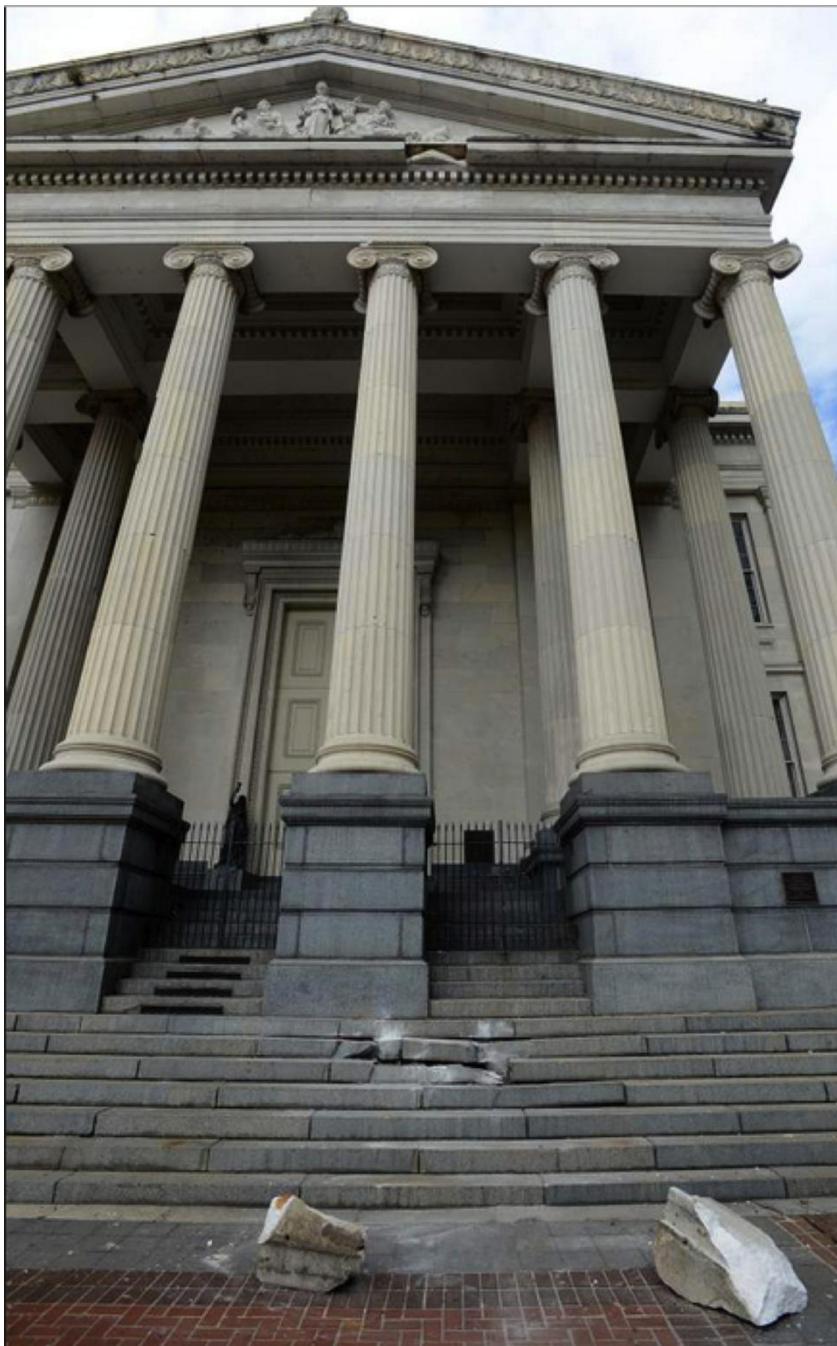
In the predawn hours of the morning of August 26<sup>th</sup>, 2014, a section of marble cornice approximately 5 feet long sheared off of the façade and fell onto the granite stairs below. The stone pieces from both the façade and the granite were broken beyond reasonable repair. Thankfully, no pedestrians were injured in the collapse.

Police barricades were quickly erected to close the surrounding sidewalks and building conservation experts were retained to investigate the cause of the stone failure. It was determined that mortar loss allowed water intrusion into the joints of the porous Tuckahoe marble and caused ferrous metal anchors within the façade to corrode and expand. This expansion exacerbated the natural shearing qualities of the stone to generate large cracks, and eventually failure.

Large cracks were observed in many areas of the façade and without repair, the prospect of additional stone failures loomed.

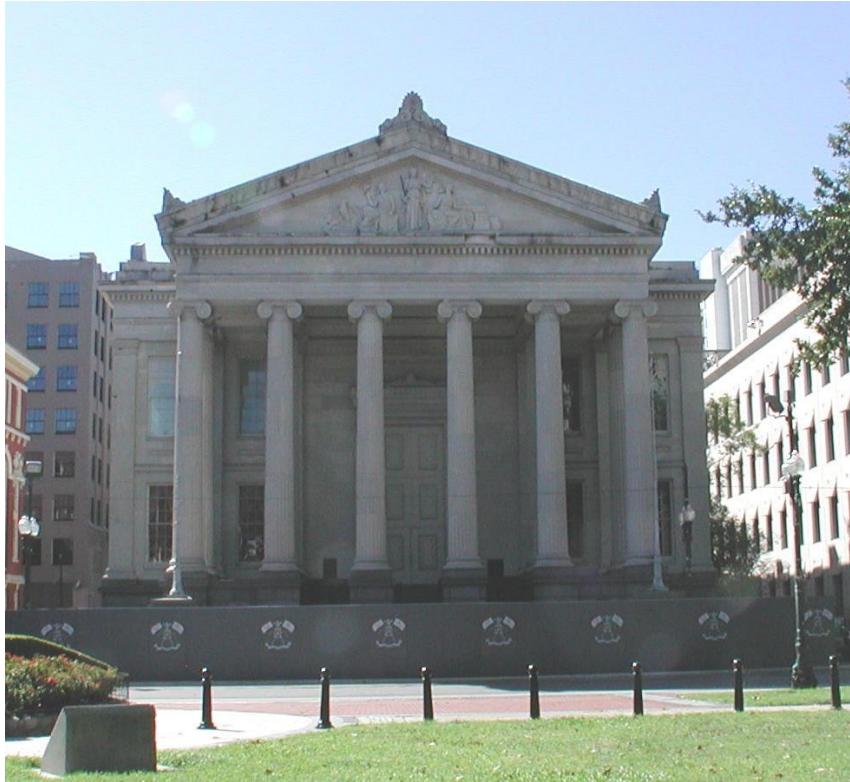
A detailed survey of the façade documented areas of deteriorated joint mortar, dimensional loss (stone areas over 2"), cracking, displacement/deformation, incipient spalling, differential erosion, mineral inclusions, previous repairs, previous stone replacements, metallic staining, mechanical intrusions, vegetation, and soiling. The findings of the survey work were documented in color-coded drawings that became the basis for formulating repair strategies and construction documentation.

The photo at top left shows the façade at the beginning of the project. Note the large amount of staining and vegetation, as well as the absent section of cornice.

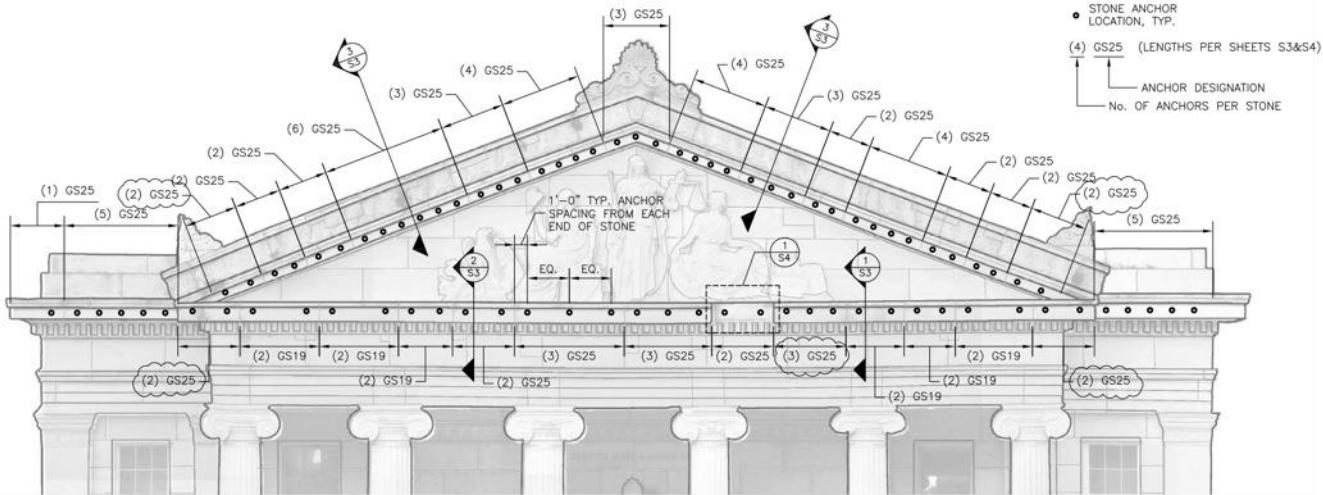
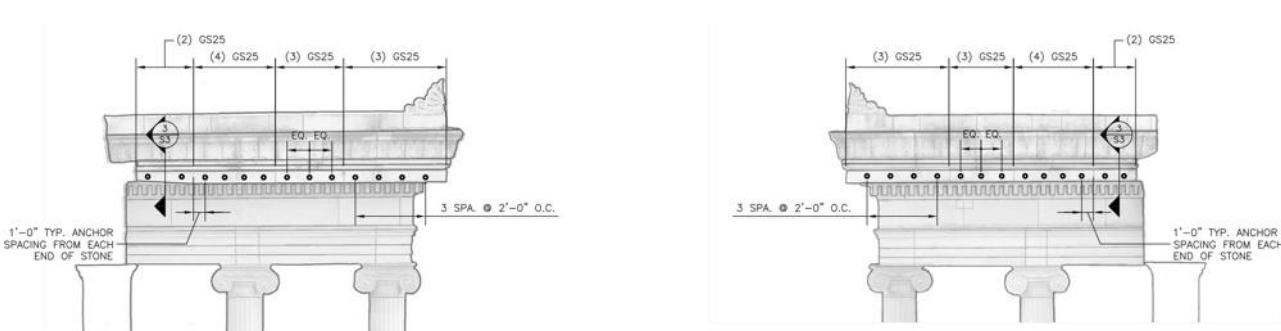
It was determined that without corrective action, the corrosion and expansion of the original 1850 ferrous metal stone anchoring hardware would lead to further failures of the stone facade.

To permanently stabilize the façade stone, an engineered pinning solution using the Gruenstark anchoring system was designed. Hollow stainless steel threaded rods and fabric bladders were placed into core holes drilled into the existing stone. The hollow center of the rod and bladder were then injected with high strength grout.

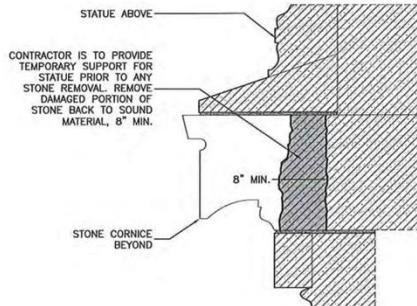
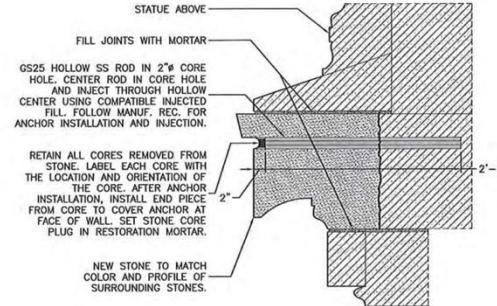
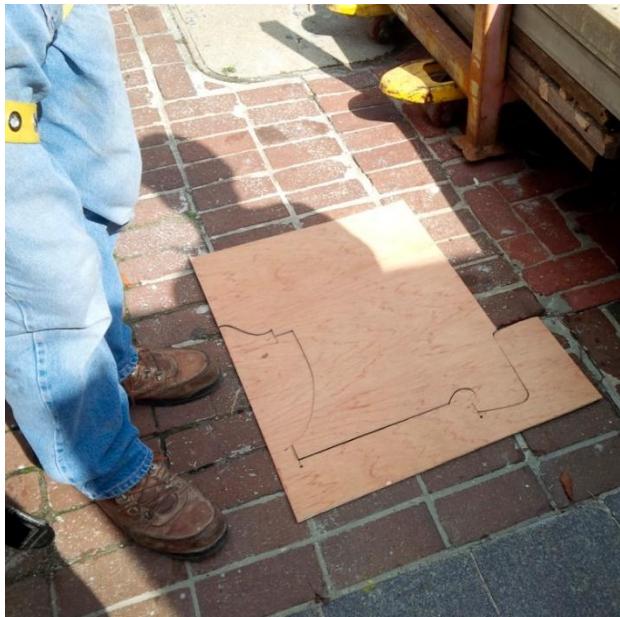
1  
S4      FALLEN STONE REPAIR  
AT LOWER CORNICE      N.T.S

The fallen segment of the broken cornice shattered on impact with the steps below and was broken beyond repair.

A full-size wood template of the cornice profile was made from the adjacent stones and used to carve a new piece of marble.

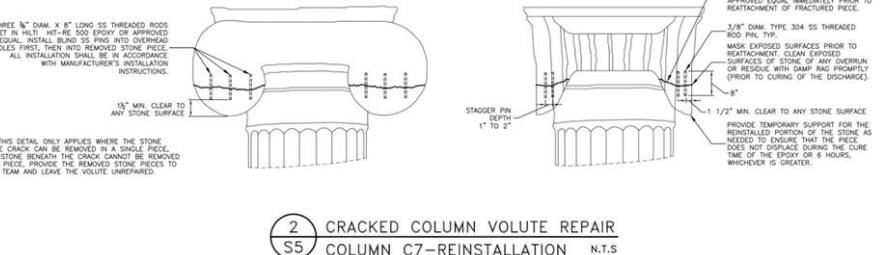
Cracks observed in the finely carved volutes at the column capitals were individually reviewed by the design team and repair contractors. Thin masonry anchors were carefully placed at various angles depending on the pattern of the cracks.

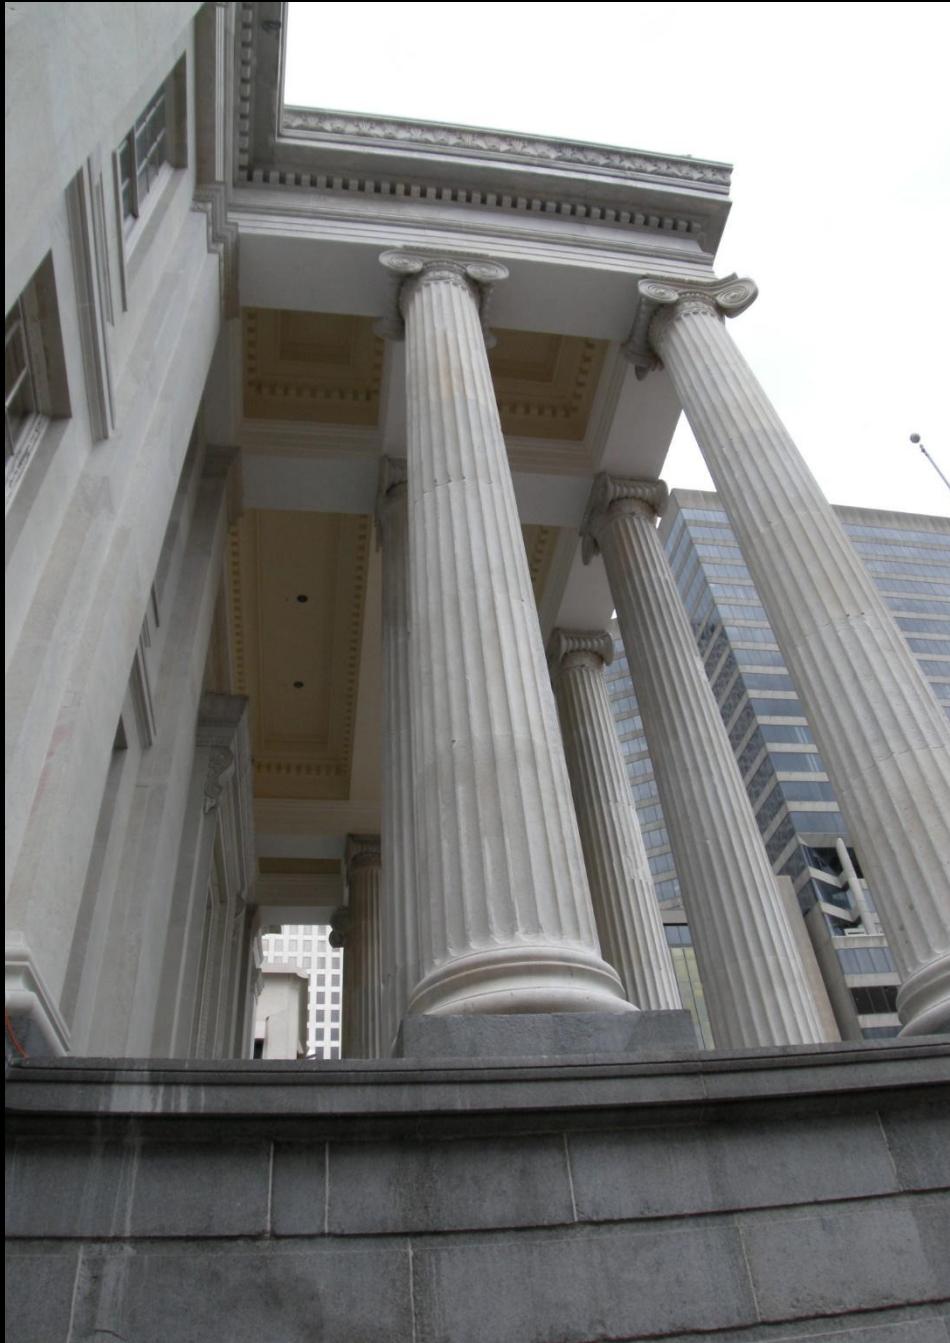
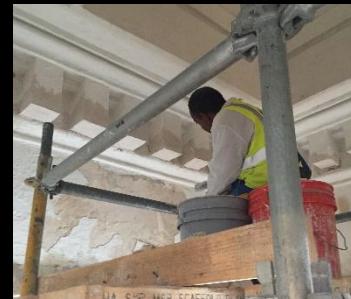
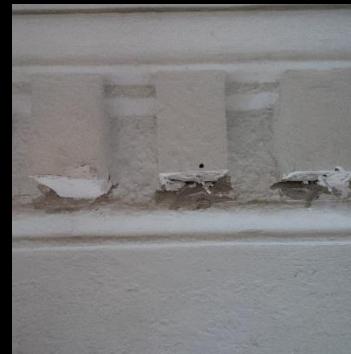
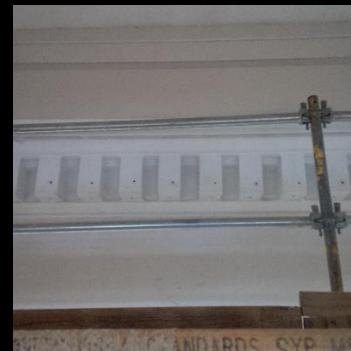
The investigation phase of the project observed failures and cracking in the plastered dentils in the soffits of the Gallier Hall portico.

The cause of failure was identified as the corrosion of ferrous metal anchors caused by the 20<sup>th</sup> century application of non-breathable coatings.

A pinning repair using thin anchors in both horizontal and vertical axis applications was developed to stabilize the underlying brick structure of the dentils. The offending coatings were removed and replaced with a lime wash coating that will allow proper breathing of the historic soffit materials.

A historic surface analysis was performed to match the color of the lime wash to the original historic colors used on the soffit.
