Program Summary:

A corner-store originally built circa 1840, with second story addition in 1886. The renovation involved surgical restoration of brick, wood, and ironwork, with complimentary modern interiors.

Project Name:
Marigny Residence

Project Location:
704 Marigny Street
New Orleans, LA 70117

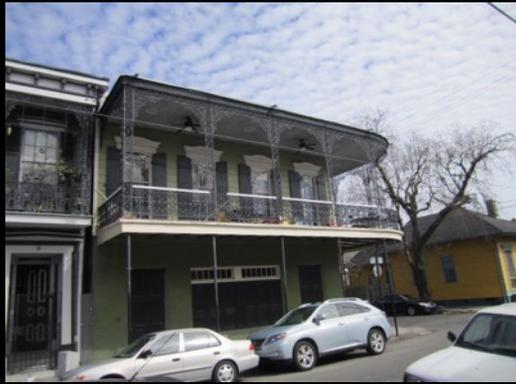
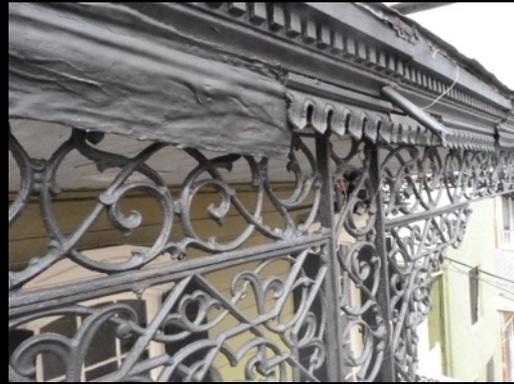
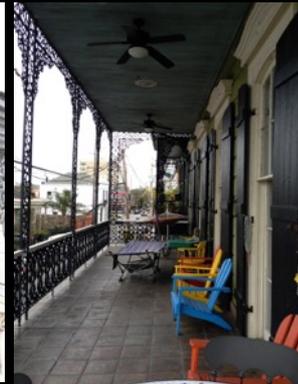
R-185.01

The Marigny Residence was a renovation with no detail left unconsidered. Originally constructed as a one story brick corner store with a 2 story detached kitchen separated by a narrow courtyard circa 1850, it was later converted to a residence in the 1880's. A second story was added in wood framing and a traditional iron gallery over the corner sidewalk. By 2012 multiple renovations and re-workings left much of the existing brick, wood, and ironwork neglected, while clunky renovations had compromised the simplicity of the original interiors. The clients requested a division of the house into three distinct living spaces: the downstairs as a guest quarters, the detached "dependency" as another guest suite, and the upstairs as an Owner's suite. Since this left little space for the Owner's suite, the attic was integrated as living space through the addition of a compact winding stair and three roof top dormers for natural light. The existing architectural features informed the development of custom millwork, finishes, and fixtures befitting each suite. Home automation all controlled from the Owner's suite allow control of the entire home. The highly complex renovation's success balanced carefully researched restoration efforts with the addition of modern amenities and interiors.

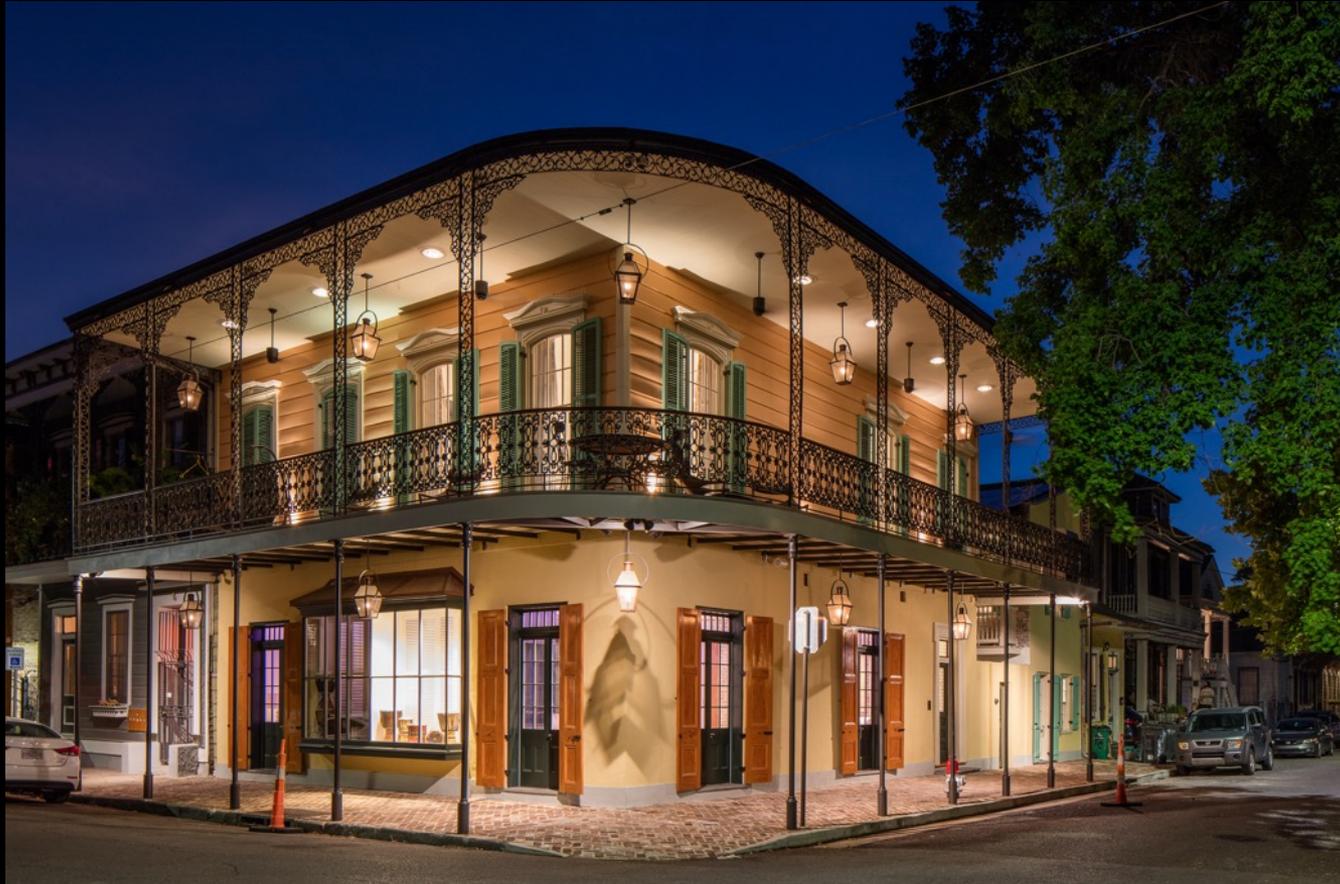
R-185.02

The exterior of the building involved restoration of all cladding materials and full restoration or replacement of all doors and windows. The ground level plaster was removed, brick tuck-pointed, and traditional lime based plaster re-applied. Due to rising damp issues (water wicking up out of the ground through brick walls), a mud band was installed at the sidewalk edge. This is a highly breathable sacrificial stucco band that can easily be repaired. At the top of this band, we saw-cut a continuous through-wall joint into the brick and inserted a sheet of lead to prevent water migration up the wall. All ironwork was removed, and the gallery temporarily braced. The ironwork was powder coated and reinstalled. Along the western facade, the building is between 12-18 inches away from the neighboring structure. The existing wood clapboards, probably dating to the 1880's were rotting an inaccessible. This wall was entirely removed from the inside of the house, and replaced with a metal clad wall, tilted up from the inside of the house. In addition, the shi lap siding at the second level was entirely removed so that plywood sheathing and a proper weather barrier could be added. The siding was reinstalled over furring strips creating a rain screen assembly. Roofing at the gallery was an asphaltic membrane system and replaced with standing seam copper. The main roof shingles were replaced with composite slate tiles. The vitrine (large projecting window) was added as was likely the condition prior to 1900, though there was no photographic evidence of this. New sidewalks and exterior gas lanterns.

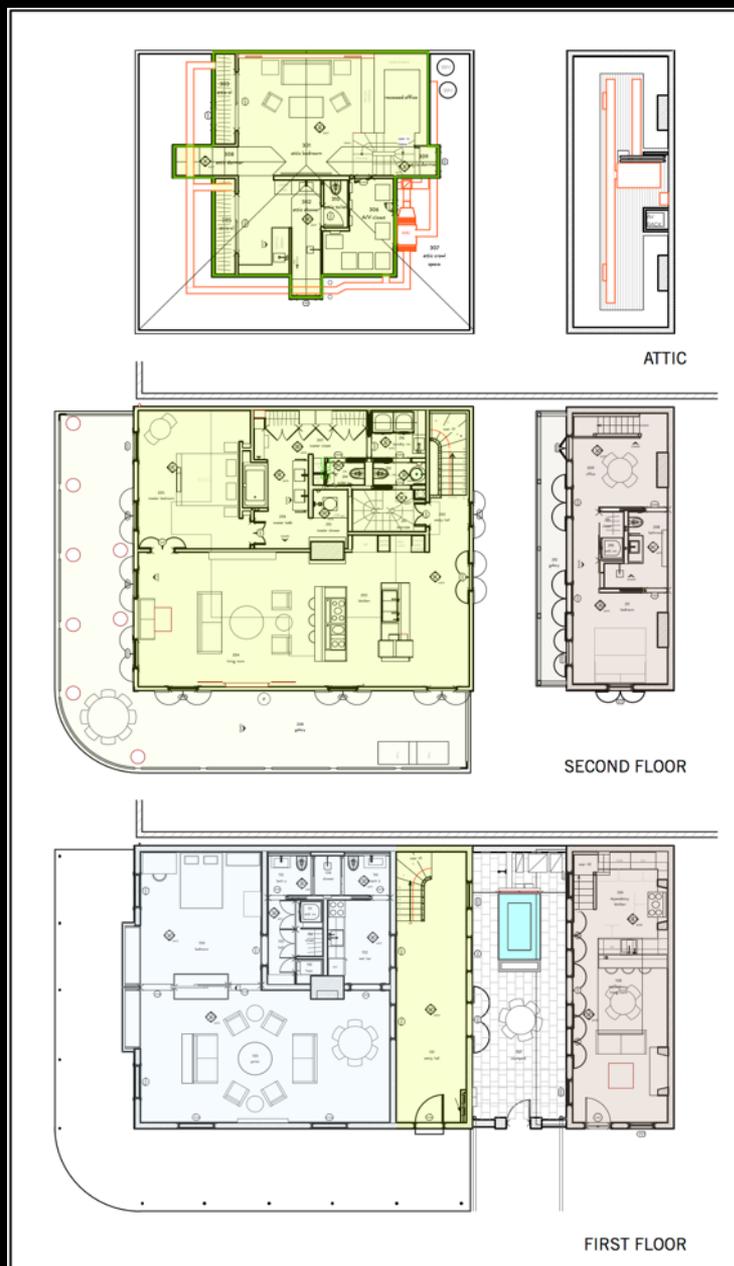
R-185.03

Plan south the historic entry gallery gives access to the second story Owner's suite via curving staircase. The Owner's suite at the second floor uses two islands as a way to integrate a full modern kitchen while allowing existing slip-head windows all to remain as operable openings and points of access to the corner gallery. Similar to the ground level, the master closet, bath, and laundry facilities are grouped into one quadrant to allow the main living spaces to feel open and uncompromised. A winder stair leads up to the former uninhabitable attic space. The office occurs as about two-thirds the way up the stair over the master bath space below, while the sound proofed main space functions as a viewing room. A bathroom is tucked behind the viewing wall, with a shower built within one of the three dormer spaces.

The first floor guest suite is accessed plan left from the sidewalk, and occupies the original corner store footprint. A jack-and-jill type bathroom, closets, and compact bar kitchen occupy the north-east quadrant allowing the original store space to remain open. The bedroom utilizes a custom floor to ceiling wardrobe/bar cabinet with full height pocket doors as a room divider. The vitrine window acts as a cabinet of curiosities for passersby, a common feature in the Vieux Carre and Marigny neighborhoods.

The dependency suite is accessed from plan south along the sidewalk, or through the courtyard. The ground level functions as a poolside kitchen and lounge, while the upstairs works as a bedroom suite. The bathroom utilizes pocket doors to allow it to float within the space as a contained volume.

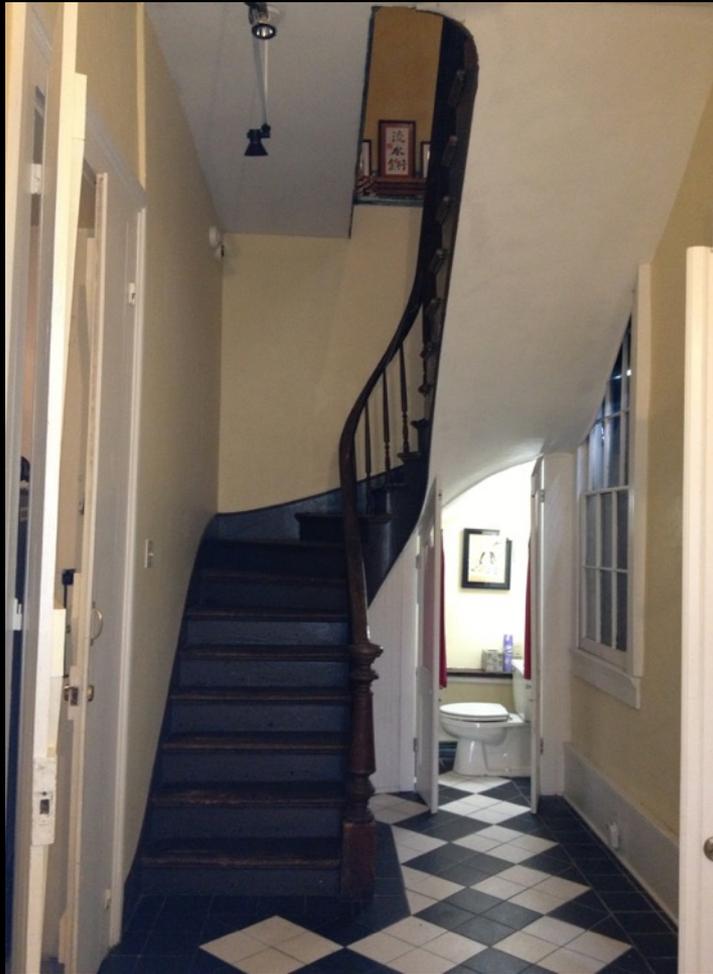
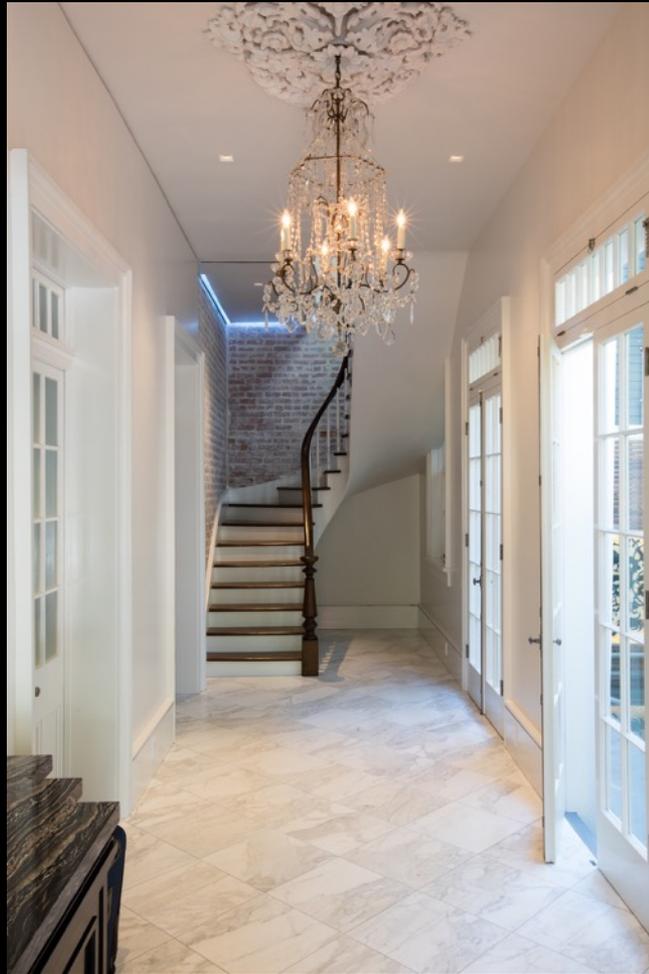
R-185.04

The Owner's suite entry gallery floors in white marble honor a traditional approach to the main residence above. Custom plaster medallion by New Orleans native and master craftsmen Jeff Poiree is the highlight. The existing wood stair, retrofitted in the 20th century with a powder room underneath, was restored to its original configuration. Original railings and treads were removed, sanded and repaired, and reinstalled. A very minimal reveal along the top edge of the brick wall (image left) allows the brick wall behind it to release and rising damp into the conditioned space of the home. Sheetrock and baseboards are mounted on furring strips over existing brick walls concealing all electrical conduit. Doors (image right) lead into the courtyard, while doors image left lead into the guest suite lending much flexibility to how the spaces are used.

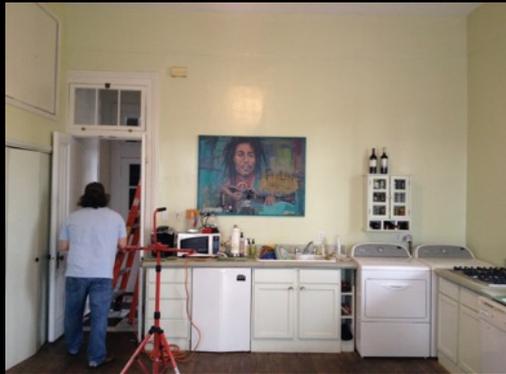
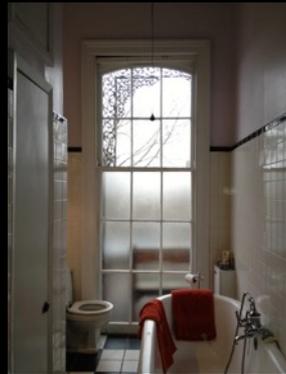
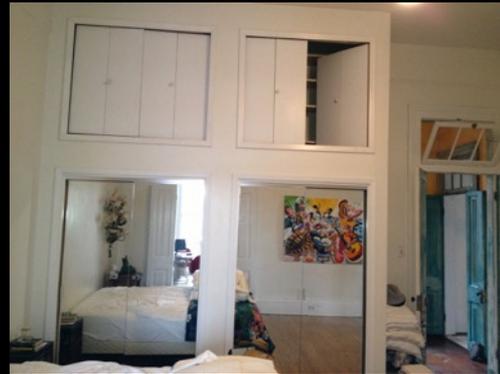
R-185.05

The main living space of the master suite involved removal of a bathroom (behind Bob Marley painting) to restore the full dimension of the space. Walls and ceilings were fully re-leveled and refloated with smooth level five finish. Concealed speakers and floated with a thin skim coat within the walls and ceiling controlled via home automation by any smart device. Wall mounted cabinet (image right) conceals a TV with custom painted aluminum honeycomb panel by Margaret Evangenline. Air conditioning is distributed with slot diffusers fed by ductwork in attic crawl space. Slip-head windows were restored, and antique replacement glass used as needed.

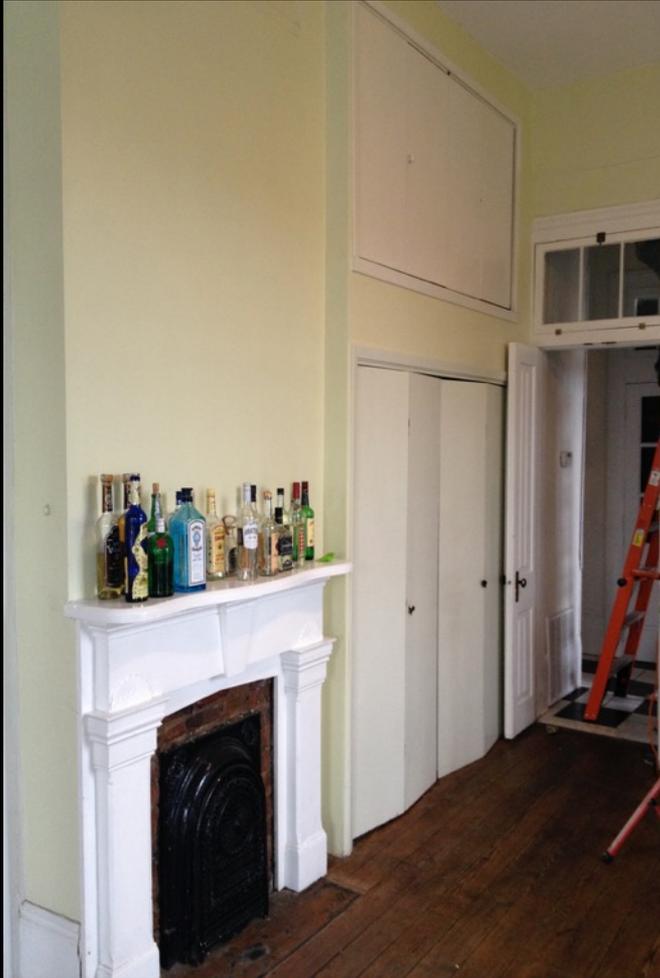
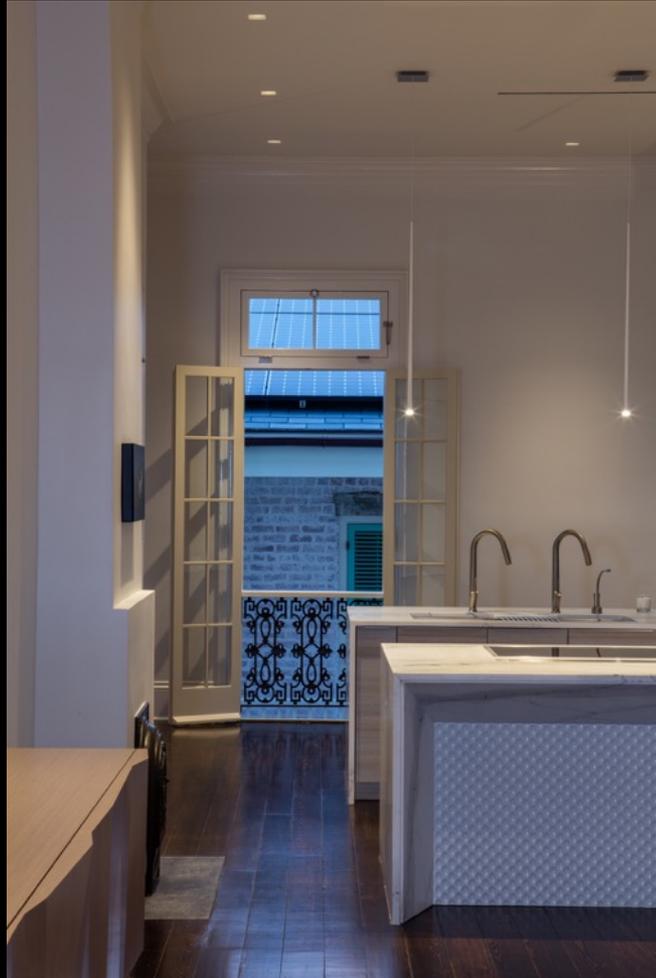
R-185.06

Kitchen cabinets by Gaggenau, and marble top waterfall counters were book matched. Existing Juliette balcony restored with replacement railing to match the main gallery. Closet furr-out was removed and replaced with seamlessly integrated refrigerator wall and pantry cabinetry. All floors refinished and repaired where damaged by walls or furniture.

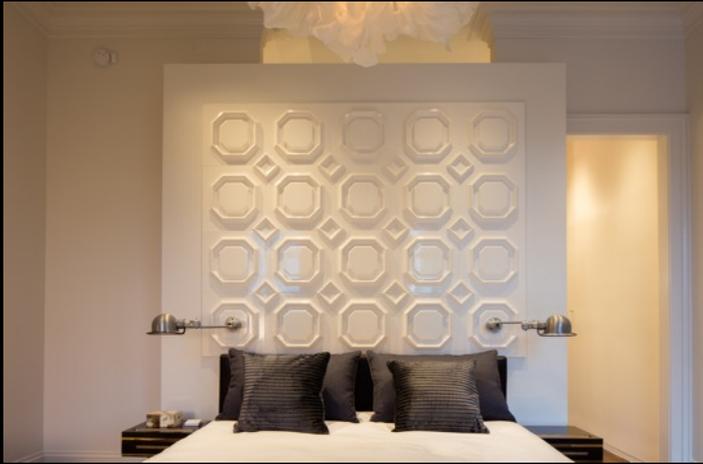
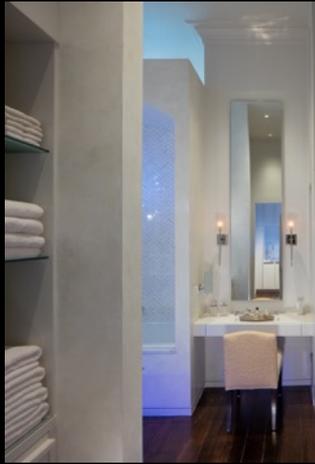
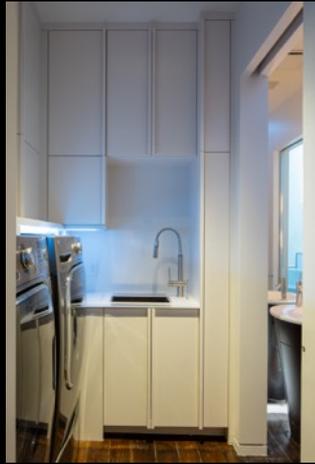
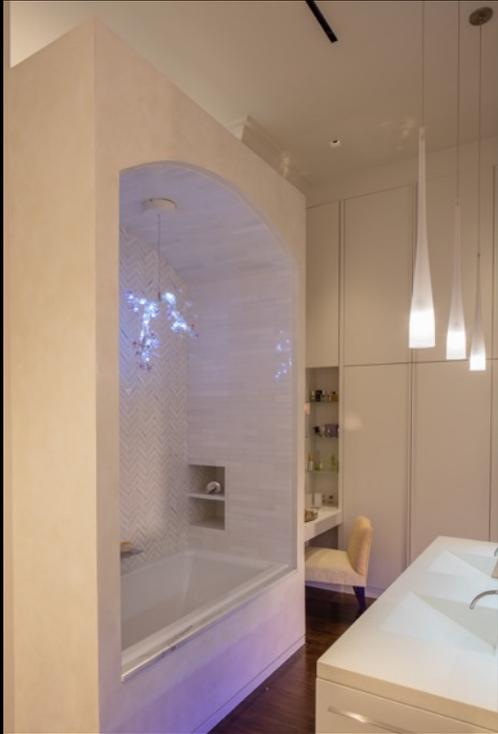
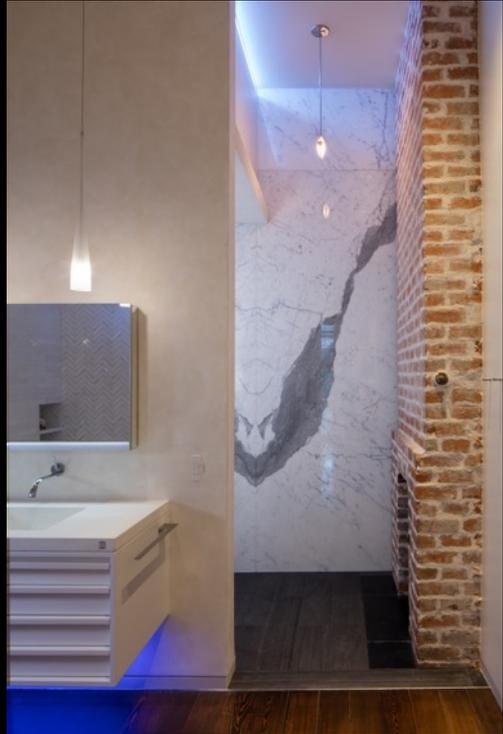
R-185.07

The master suite involves a compact arrangement of program: bedroom, five fixture bath, vanity, closets, powder room, and laundry. Using the powder room as a pass through to the laundry allows access without going through the master bedroom. The walk-in shower is clad with book matched full height marble slabs carefully laid out and installed using a chain lift hung from the ceiling joists above. Opening above the bathtub volume brings indirect natural light into the bathroom through the bedroom. Closet doors fabricated with Apple-Ply plywood, and sprayed conversion varnish. Utility sink at laundry with 3form transparent counter. Mirrors used through out the space to share light and extend sense of dimension.

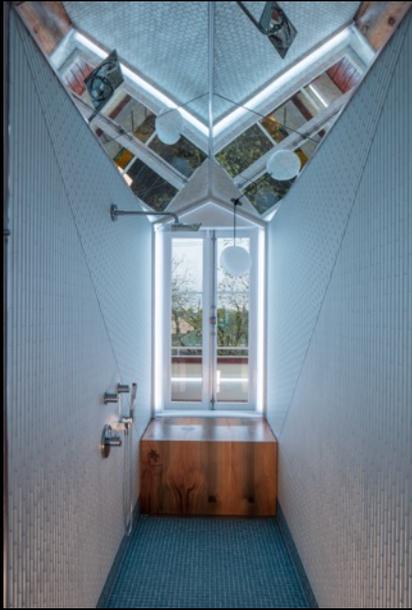
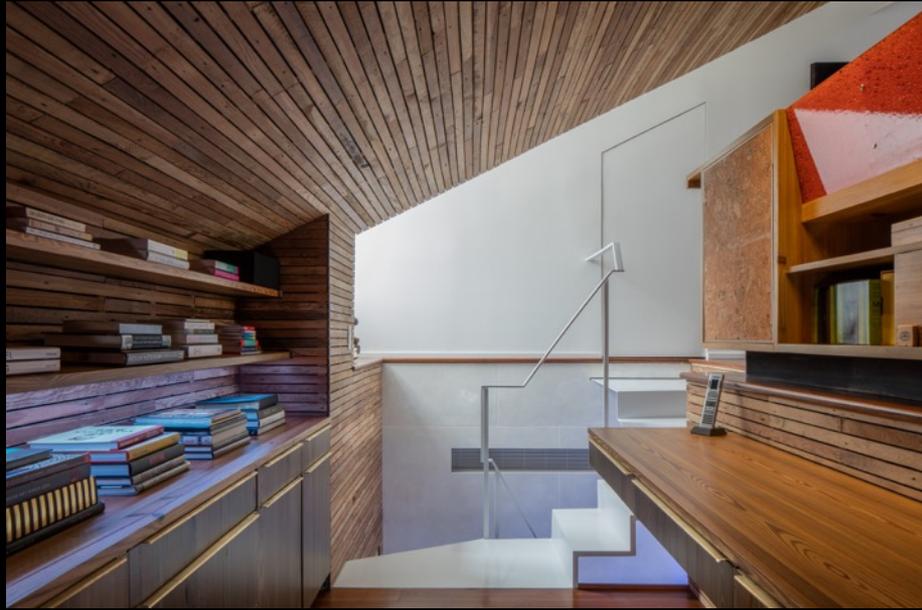
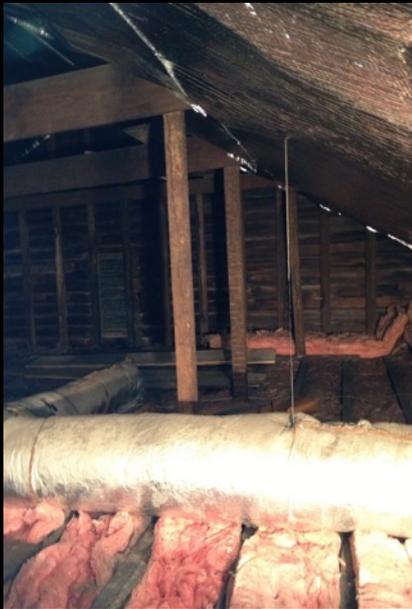
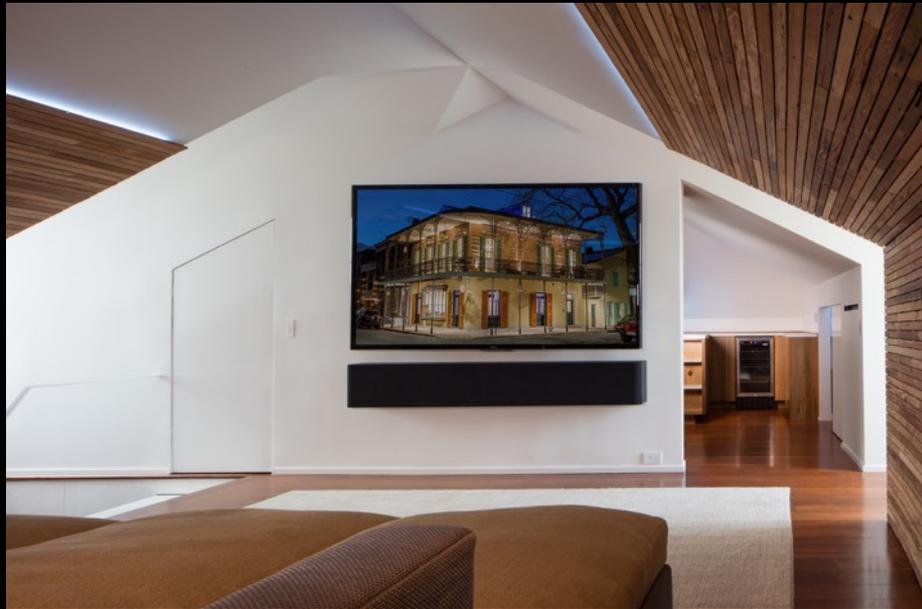
R-185.08

Custom steel winder stair leads to attic. Folded steel treads are welded to angle flanges bolted to each wall stud and then concealed with mdf panels at walls. Wall panels finished in venetian plaster. Staircase finish is 9 part boat paint finish. All stair geometries for treads, risers, and railings mocked up on site with plywood prior to fabrication off site. Niches in walls, lined with concealed LED tape lighting, to be used by Owner's for art objects. Stair accesses office at about two-thirds height landing, and continues up to main viewing room. Roof access for servicing via dormer window.

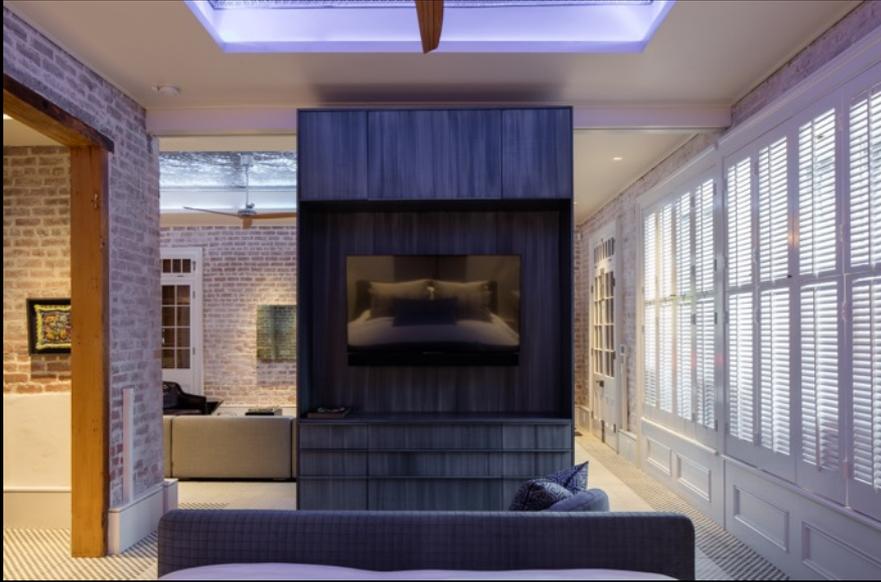
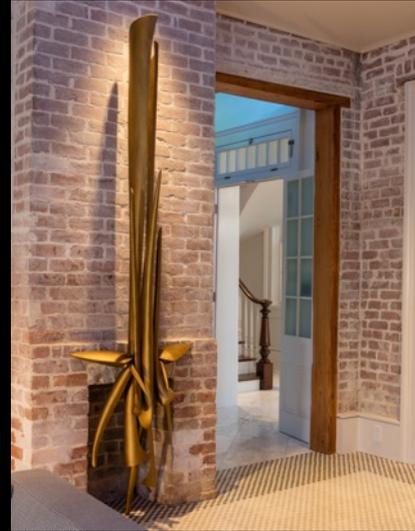
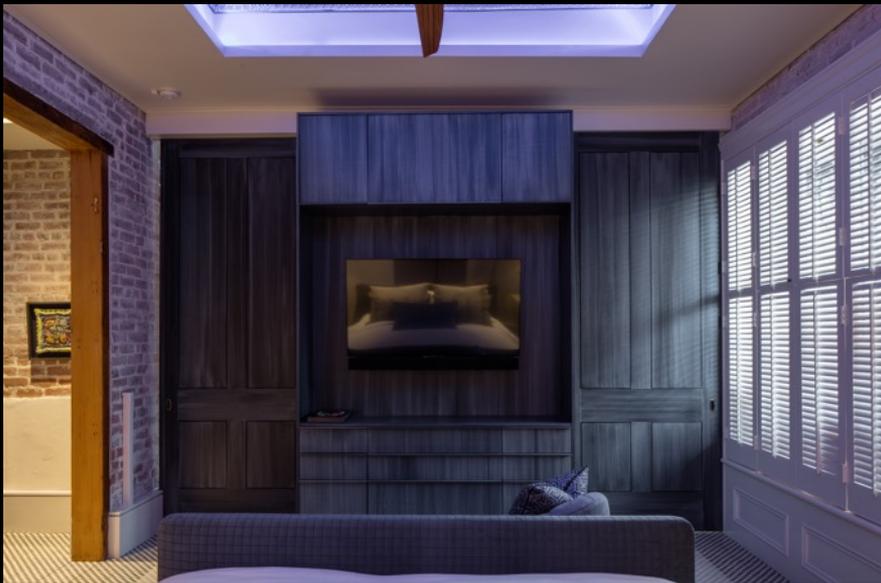
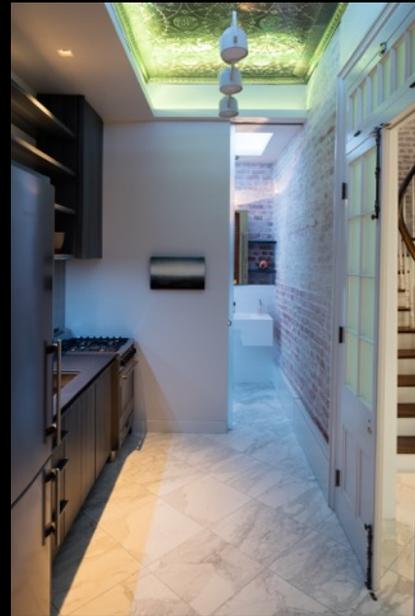
R-185.10

Guest Suite on ground floor with cement floor tile in gray and white, with accent black and white tiles at perimeter. With brick walls, ductwork needed to be overhead, and is incorporated into cove ceiling detail, with traditional pressed tin in taller sections. Guest bedroom can open to main parlor room by opening full height pocket doors. Cabinets finished with "Elvis blue" wash paint finish, a mix of black, blue, and gray streaks.

In the parlor, sculpture by David Borgene sits in front of historic fireplace location, and leads to small wet bar beyond. Wet bar with matching Elvis blue cabinetry, and countertop in recycled paper composite panels. Backsplash with antique mirror glass. Jack and jill bathroom beyond with white glass shower to provide privacy for separate sink/toilet rooms. Cove ceilings and cool light above give a feeling of a skylight to an area of the plan with no windows.

All brick walls finished with breathable lime based wash finish.

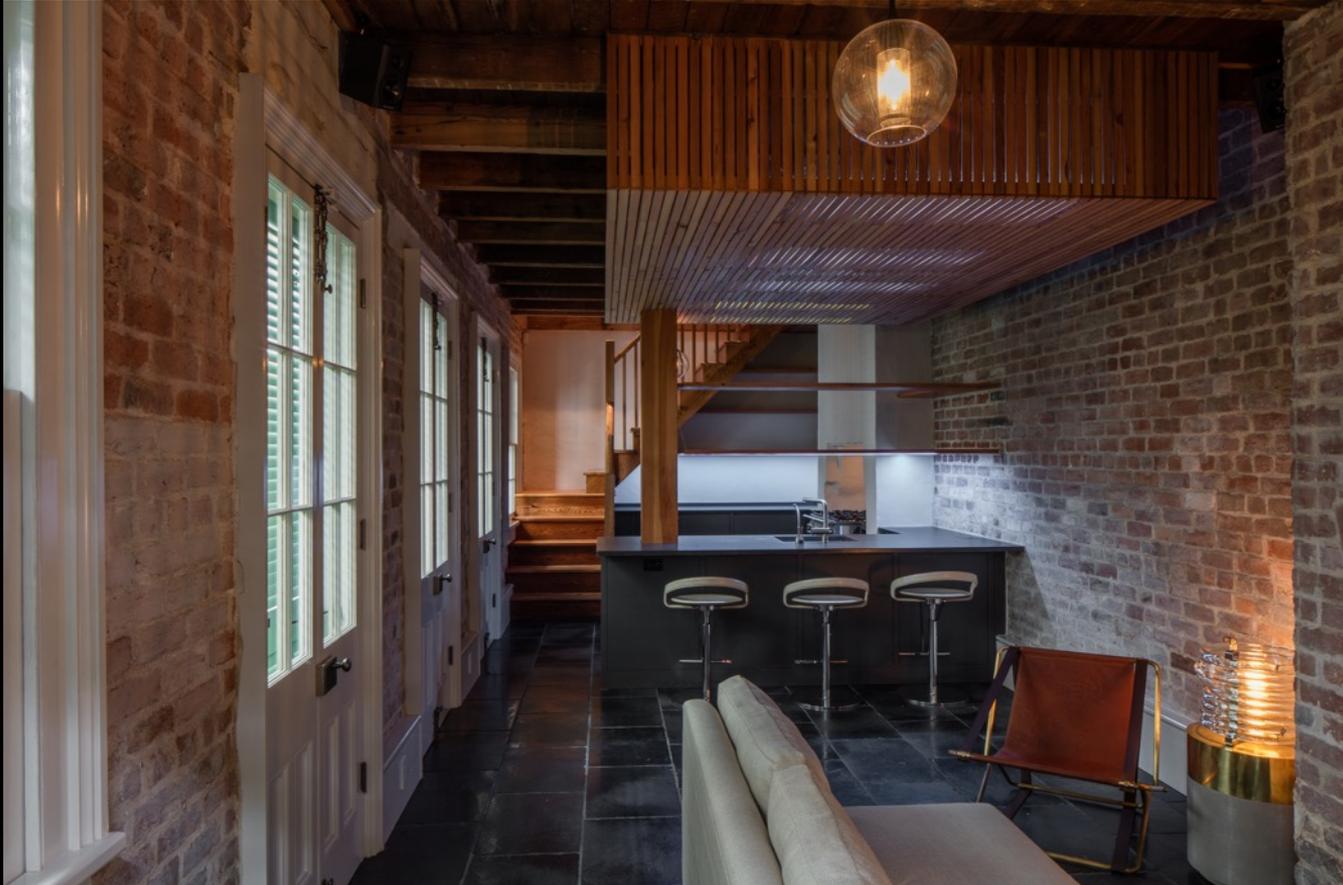
R-185.11

Dependency building accessed through the courtyard or streetside is detailed with earthy materials to maintain its intimate and historical feel. Originally used as a kitchen for the corner store, it had been renovated with a bathroom in the middle of the downstairs room in the 20th century.

We removed this bathroom and installed black stone tile for the flooring throughout. Cabinetry in cypress. Ceiling with reclaimed lath conceals mini-split heat pump system. Original stair refinished. Counters in black granite with refrigerator drawers on back wall.

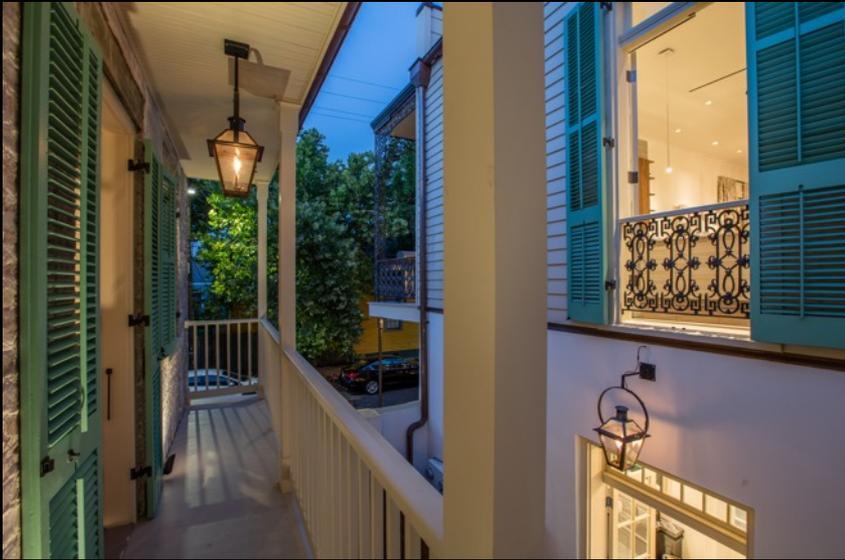
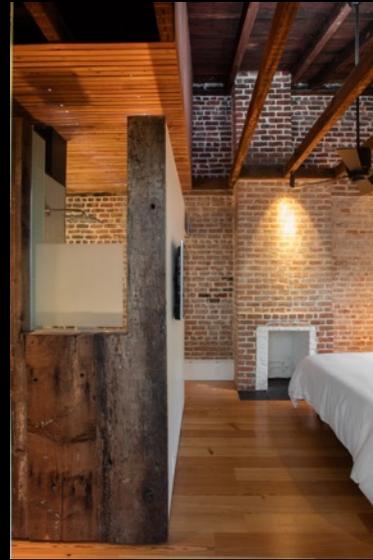
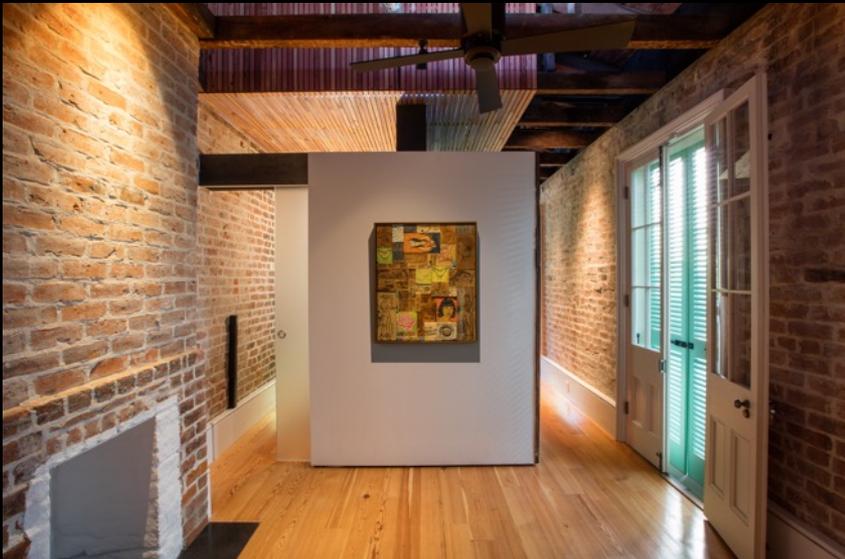
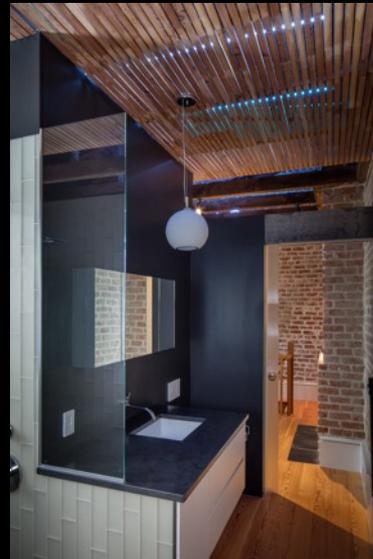
R-185.12

Upstairs includes guest suite – complete with laundry, bathroom, full size shower, and small office area. Pocket doors close off bathroom when needed, but walls float in the middle of the space to maintain a feeling of openness. Barge board wood, originally used as partitions, were re-used as cladding on the interior wall surfaces. Lighting and fans hang from above using the beams to animate shadow and light. Rigid insulation was added to the roof plane to allow attic to become part of the conditioned volume. Solar panels on the roof take the brunt of the solar load. The original gallery overlooks the courtyard below, with interesting views back to the main house.
