**Program Summary:**

The classical portico/primary façade of the historic 1850 Gallier Hall building was stabilized and restored. The restoration included both structural repairs and masonry cleaning.

## Gallier Hall

Project Name:  
**Gallier Hall: St. Charles Façade Restoration**

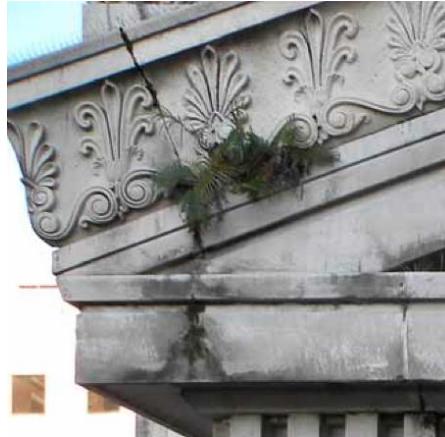
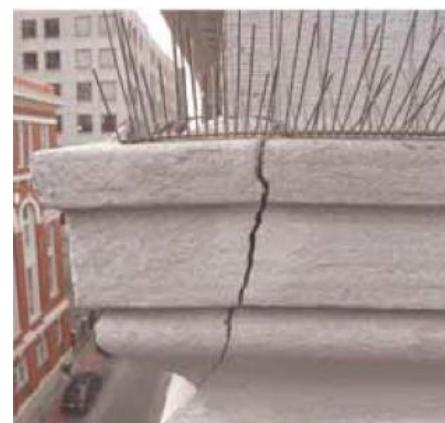
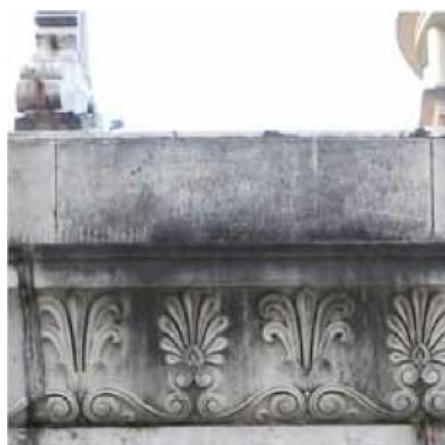
In addition to the immediate safety issue of stone failure, the investigation of the existing façade conditions found and documented many types of soiling and deterioration present on the façade.

A detailed survey of the façade documented areas of deteriorated joint mortar, dimensional loss (stone areas over 2"), cracking, displacement/deformation, incipient spalling, differential erosion, mineral inclusions, previous repairs, previous stone replacements, metallic staining, mechanical intrusions, vegetation, and soiling. The findings of the survey work were documented in color-coded drawings that became the basis for formulating repair strategies and construction documentation.

The photo at top left shows the façade at the beginning of the project. Note the large amount of staining and vegetation, as well as the absent section of cornice.

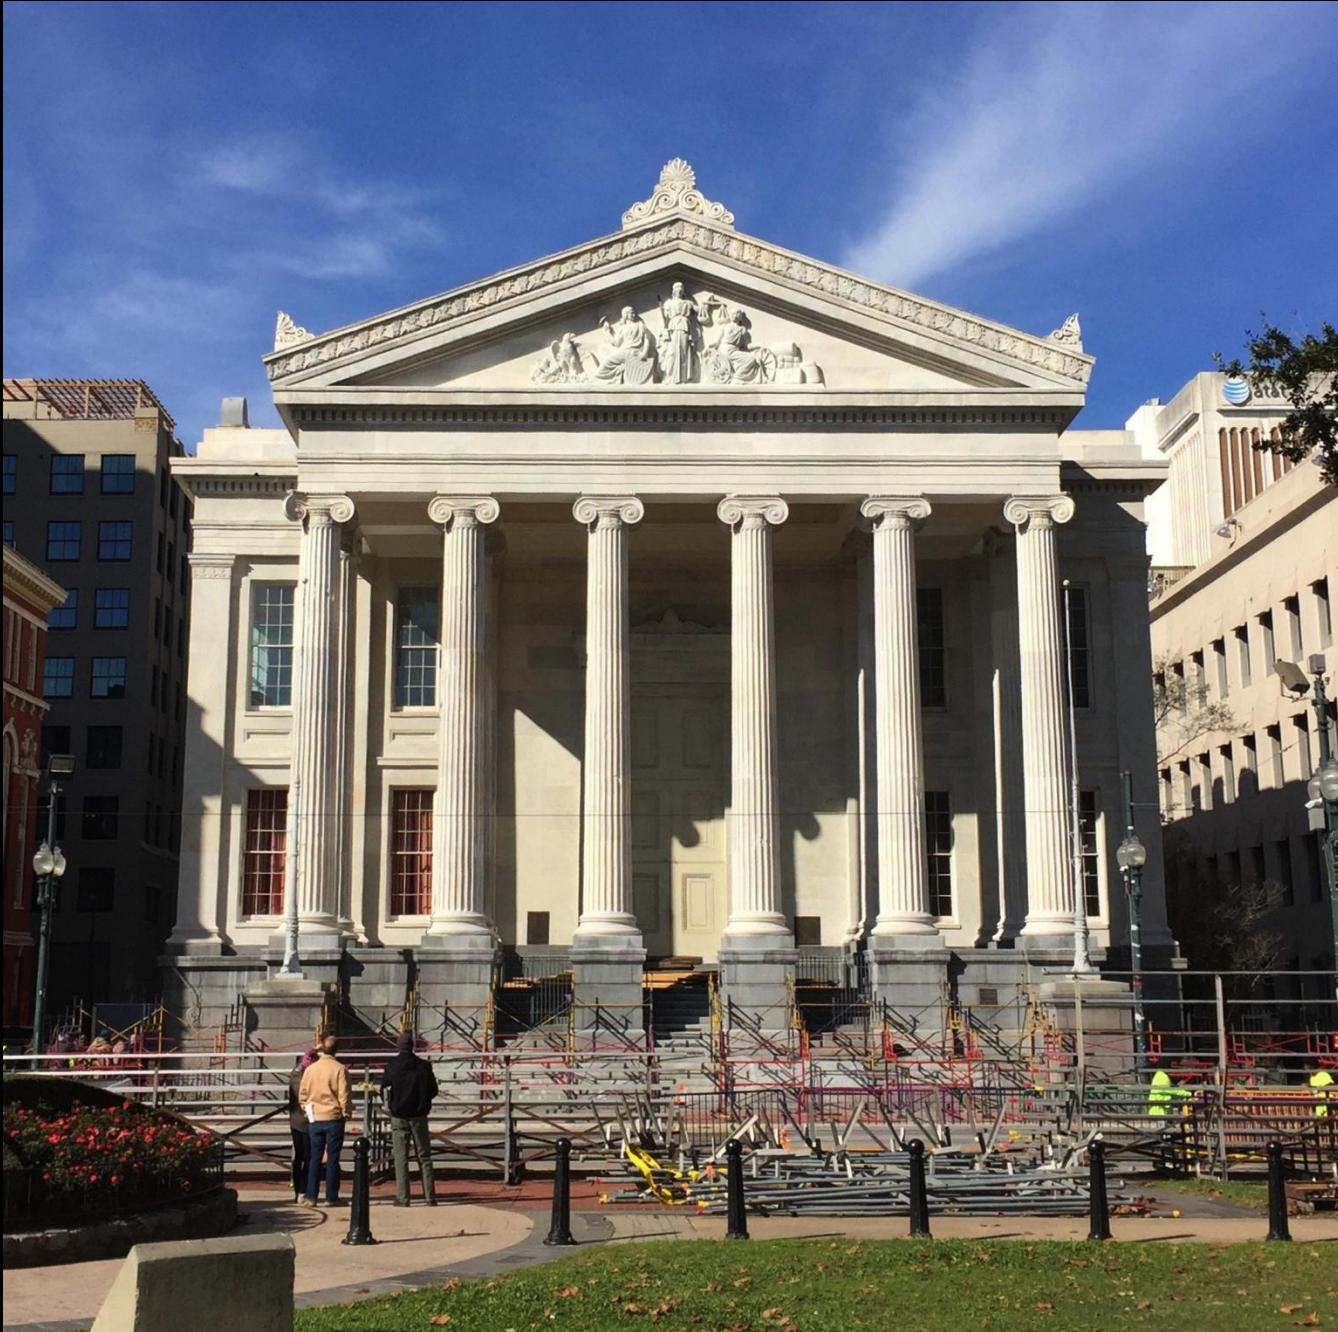
Upon substantial completion in late December 2015, the project restored the striking whiteness of the marble façade and repaired all damage from the stone failure.

In this image, the installation of the reviewing stands for the upcoming Mardi Gras parades is visible.

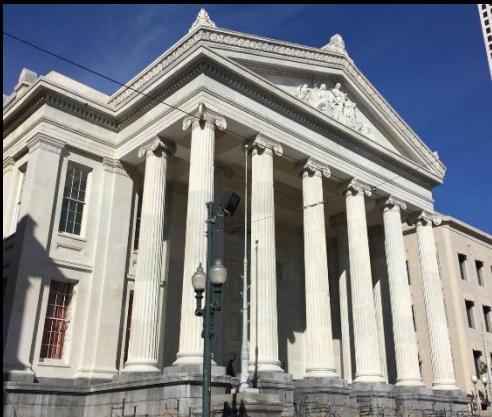
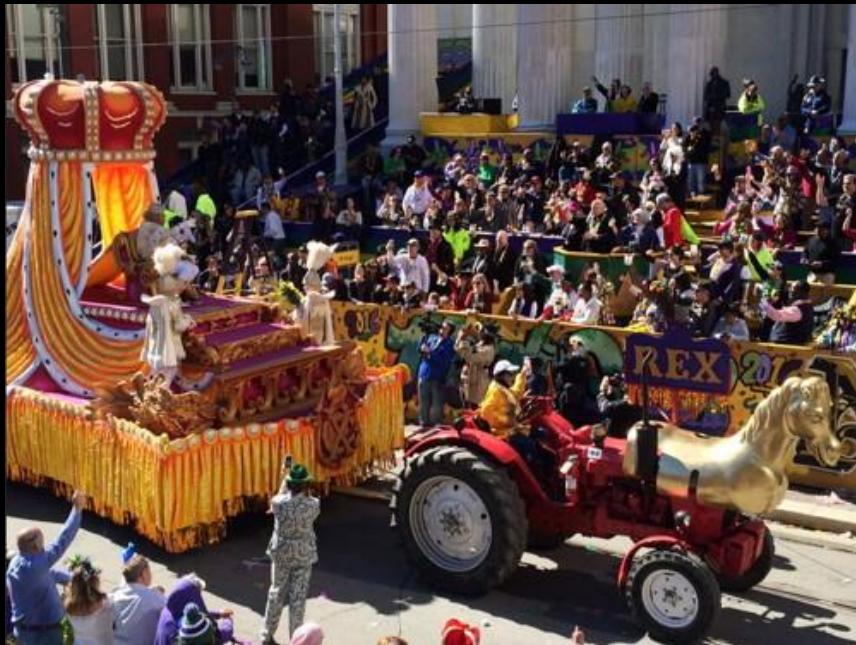
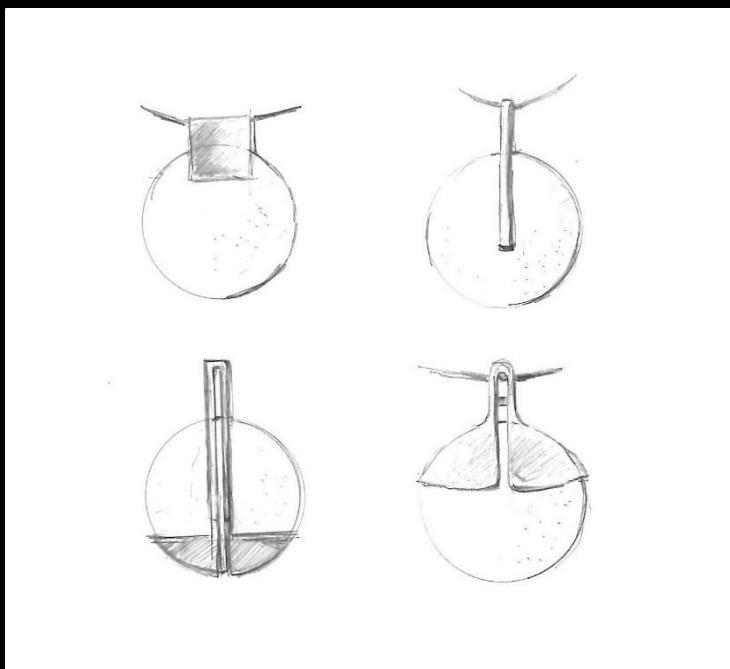
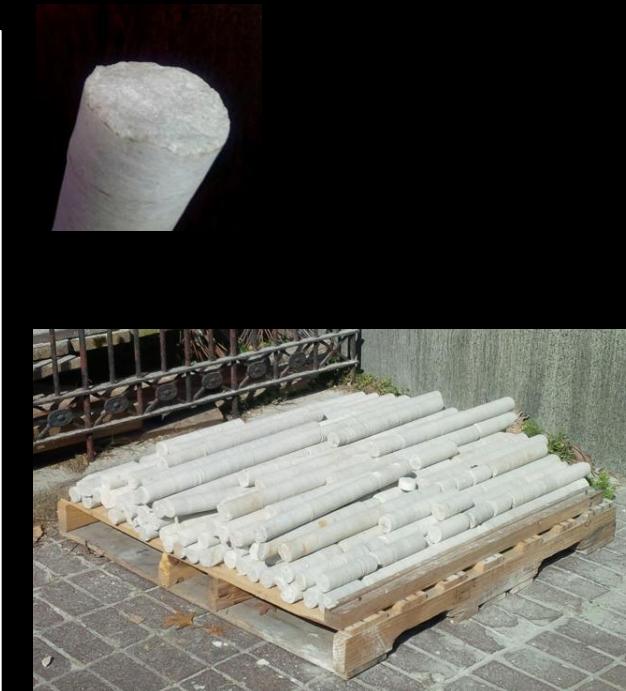
In this image, the mayor of New Orleans and Rex, the king of Carnival share a toast on Mardi Gras day, Tuesday, February 9, 2016.
